Product Change Notification
Software Release Notice

MultiTech[®] Conduit[®]
Family of Programmable Gateways:
Conduit IoT Programmable Gateway
Conduit IP67 Base Station,
and Conduit AP Access Point

Updated Firmware Available
mPower™ Edge Intelligence

Product Change Notification Number
PCN 03092020-001

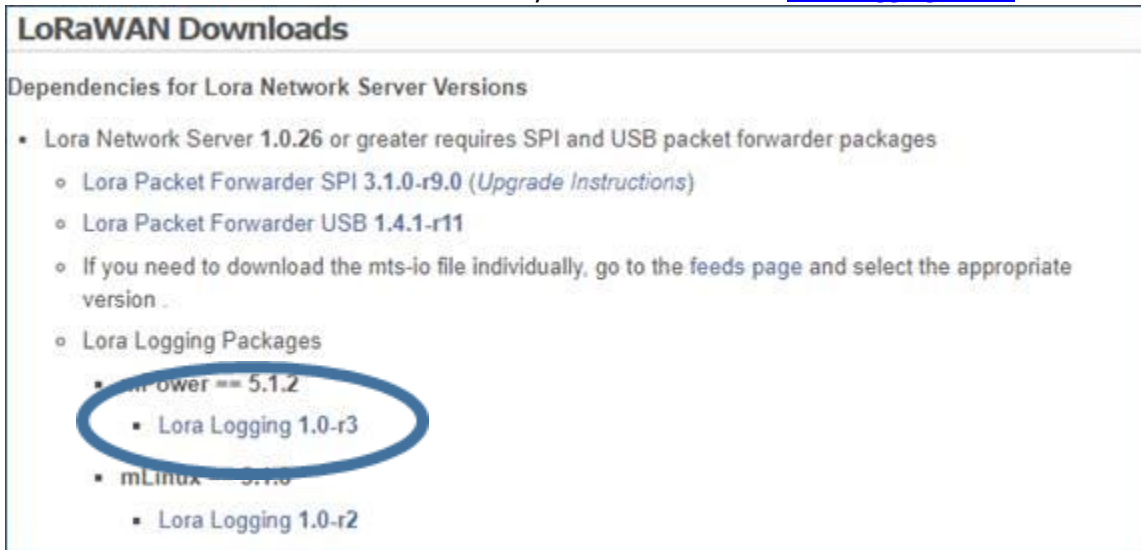
1. Visit <http://www.multitech.net/developer/downloads/>
2. Scroll down to LoRaWAN Downloads. There you will find the link: [Lora Logging 1.0-r3](#)

3. Click on the link to download the IPK file.
4. The file must be uploaded to the device. We recommend using WinSCP for secure file transfer. <https://winscp.net/eng/index.php>
5. Load WinSCP to the root of the connection
6. Access the device using SSH and run the following command
`sudo opkg install lora-logging_1.0-r3.0_arm926ejste.ipk`
You should be asked to enter your password
7. WinSCP will run and load the IPK file.

The Shell Script Update is not a full mPower firmware image, it is only designed to resolve [Critical Issue 1](#) and should only be used to update mPower MTCAP AEP 5.1.2 and mPower MTCDT AEP 5.1.2
