Product Change Notification Software Release Notes

mPower™ Edge Intelligence Software mPower 5.3.3

Product Change Notification (PCN) Number
PCN 03292021-001 (mPower - Conduit)

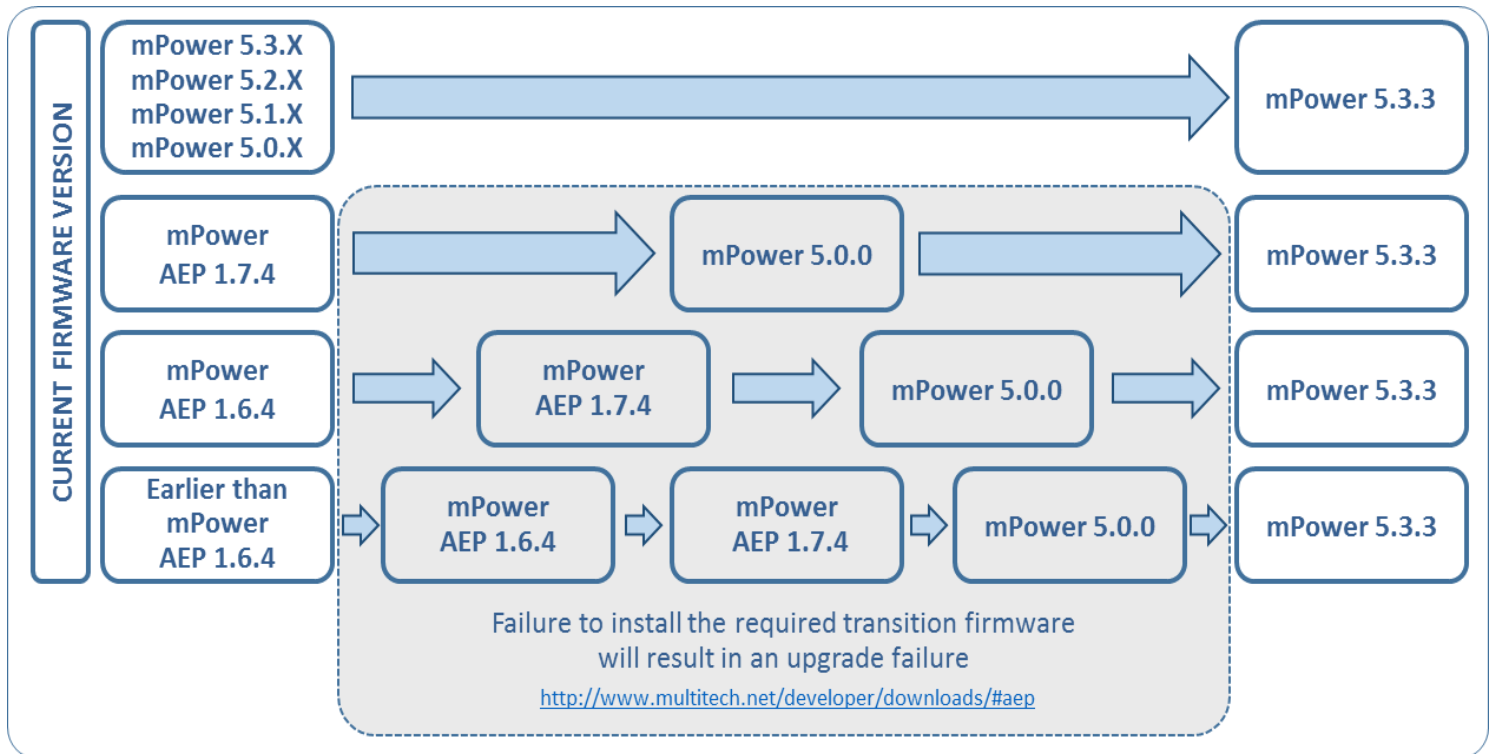
To install mPower 5.3.3, the Conduit gateway must be upgraded to mPower 5.0.0 or higher. Customers that are running earlier versions of mPower should use the following upgrade process:
