Product Change Notification Software Release Notes

mPower™ Edge Intelligence Software mPower 5.3.3

MultiTech Conduit® AP Access Point MultiTech Conduit® Programmable Gateway MultiTech Conduit® IP67 Base Station MultiTech Conduit® IP67 200 Series Base Station

Product Change Notification (PCN) Number
PCN 03292021-003 (mPower - Conduit)

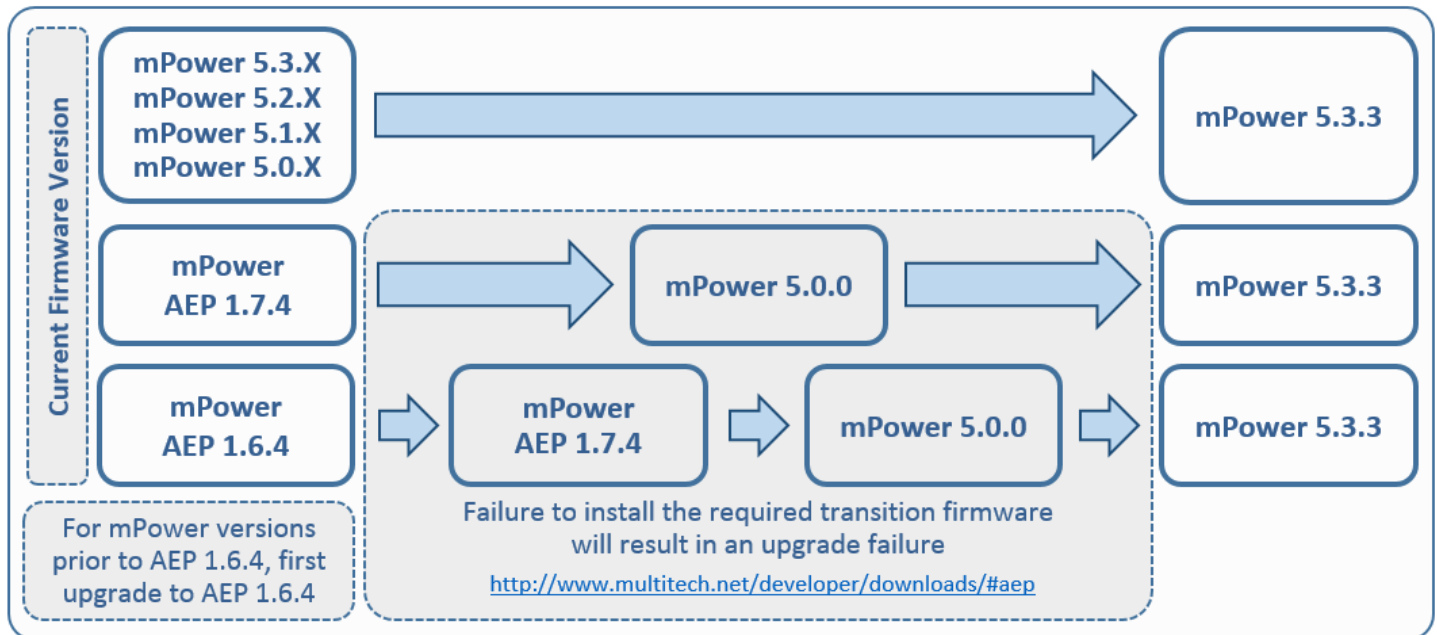
Minimum System Requirements (mPower 5.3.3)

To install mPower 5.3.3, the Conduit gateway must be upgraded to mPower 5.0.0 or higher. Customers that are running earlier versions of mPower should use the following upgrade process:
